# Owyhee Dairy Complaint Investigation Report

By Emily Montague

May 22, 2019

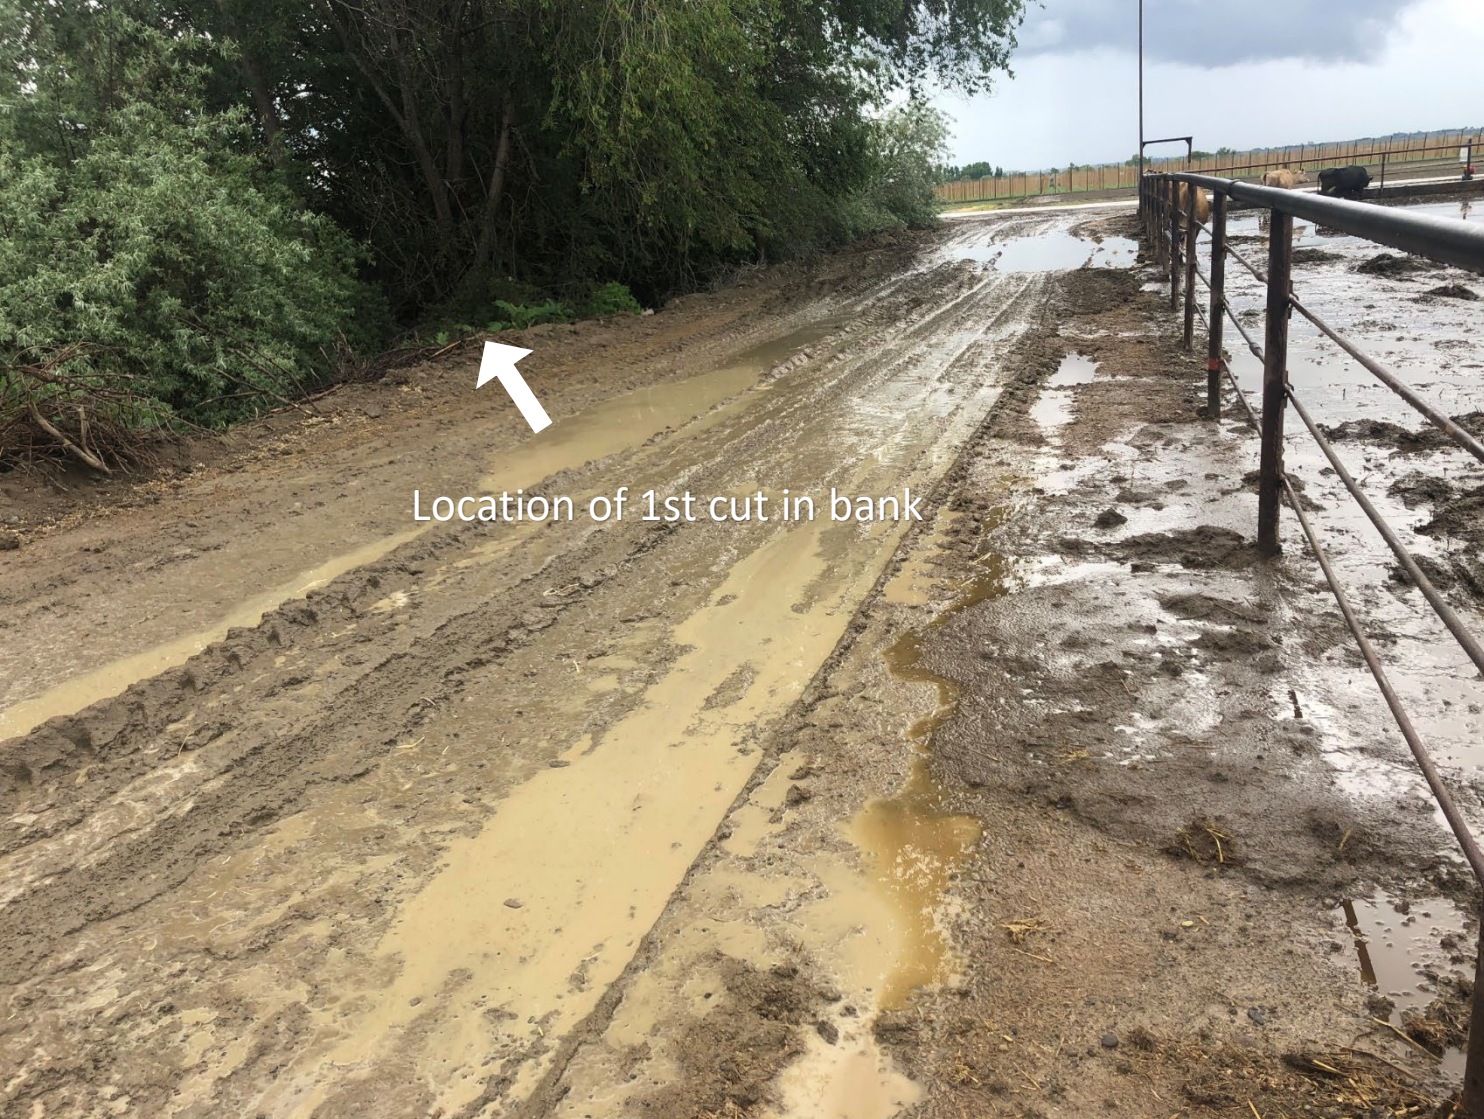
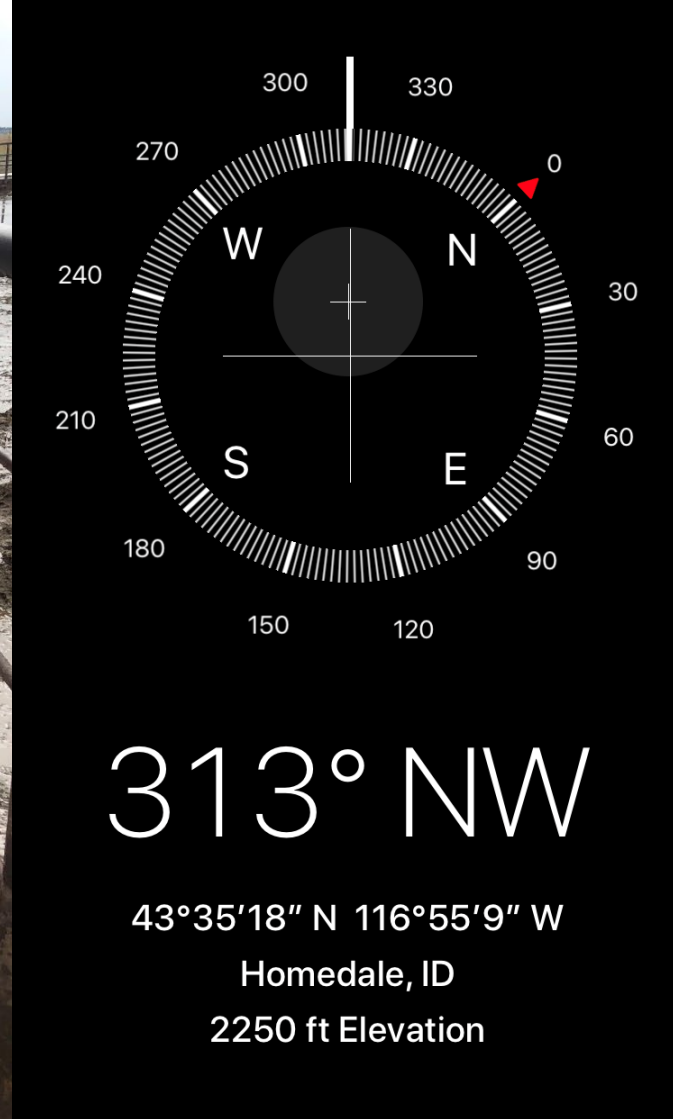
Photograph taken by Inspector Montague on May 21, 2019 facing 313 degrees Northwest shows placement of the first cut in the bank between the North corrals and the ditch that borders Owyhee Dairy on the North and Northwest side of facility. Slurry and effluent are shown coming out of corrals at the time of inspection. 1 ½ - 2 foot berm that was in place along ditch bank approximately one year ago is no longer in tact along ditch bank edge.

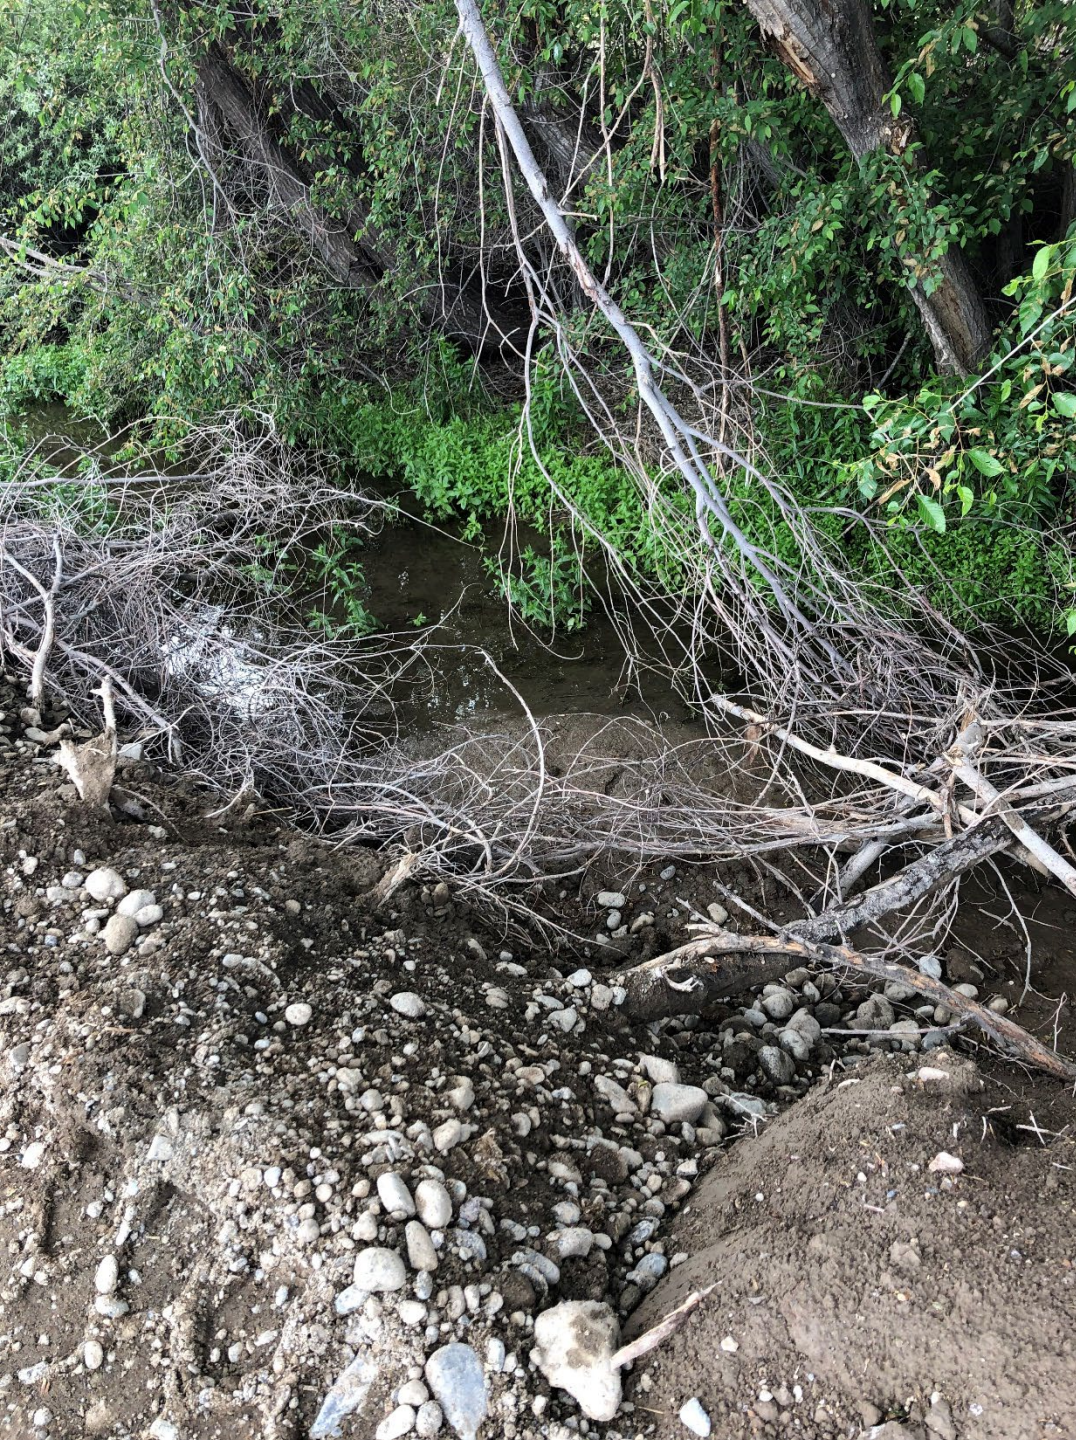
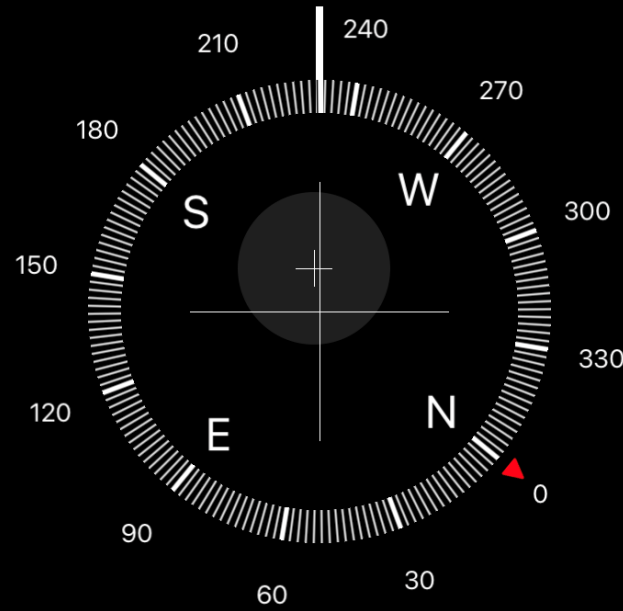
Photograph taken by Inspector Montague on May 21, 2019 facing 230 degrees Southwest shows placement of the first cut in the bank between the North corrals and the ditch that borders Owyhee Dairy on the North and Northwest side of facility. Newly placed gravel and dirt line area in this location where 1 ½ - 2 foot berm was in place along ditch bank approximately one year ago.

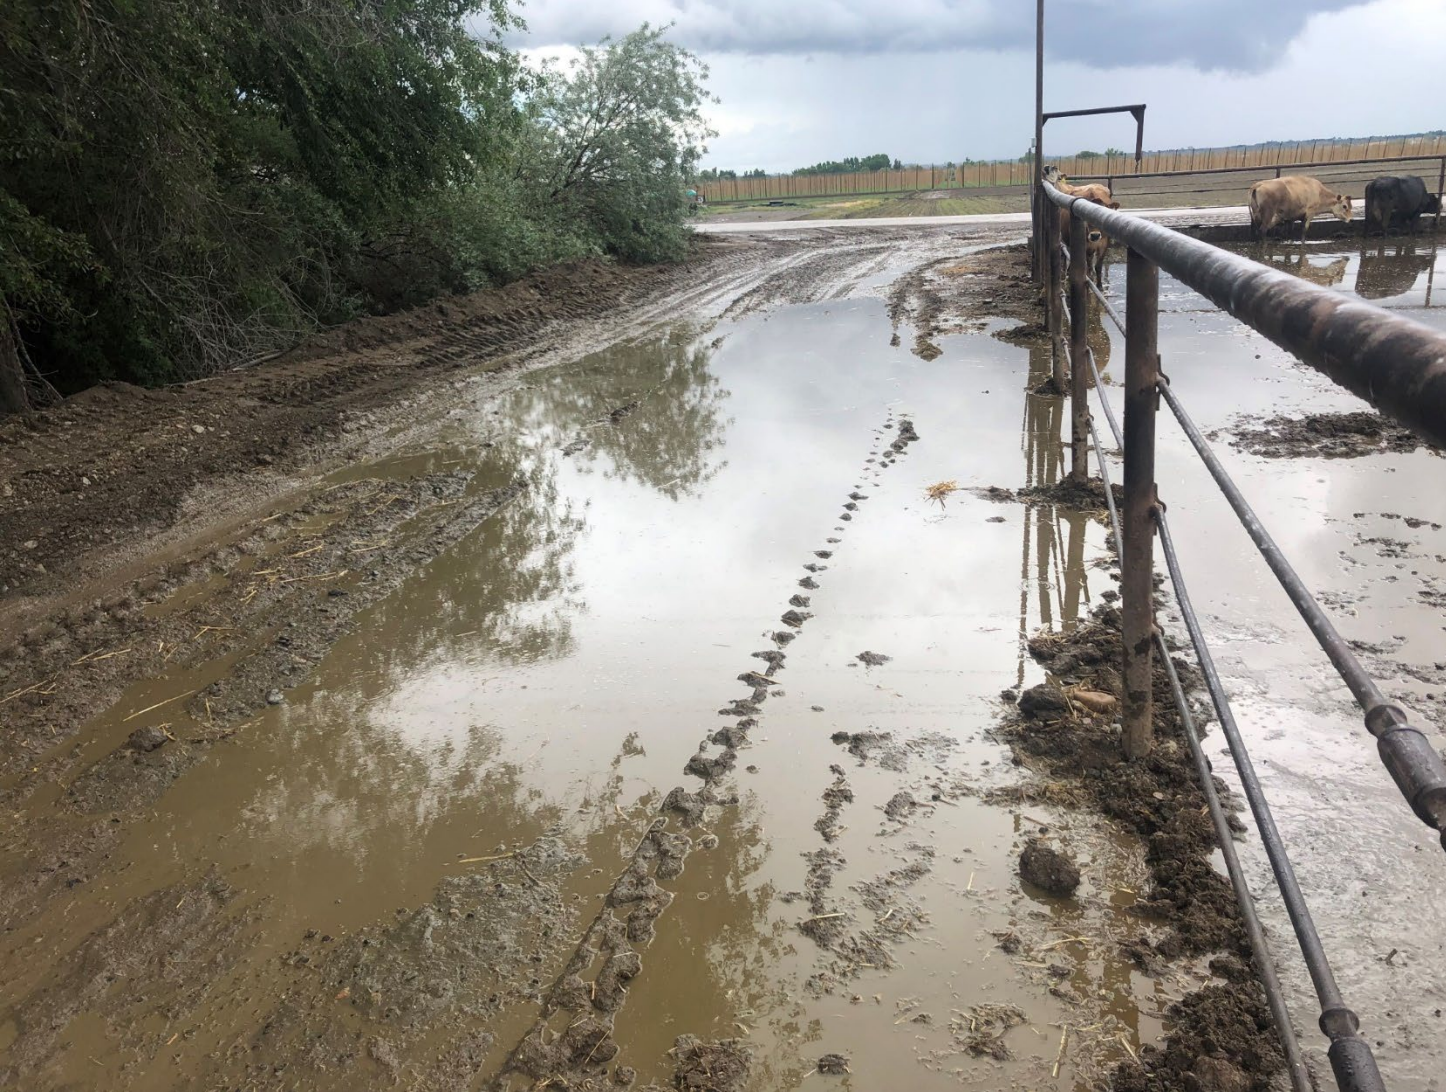
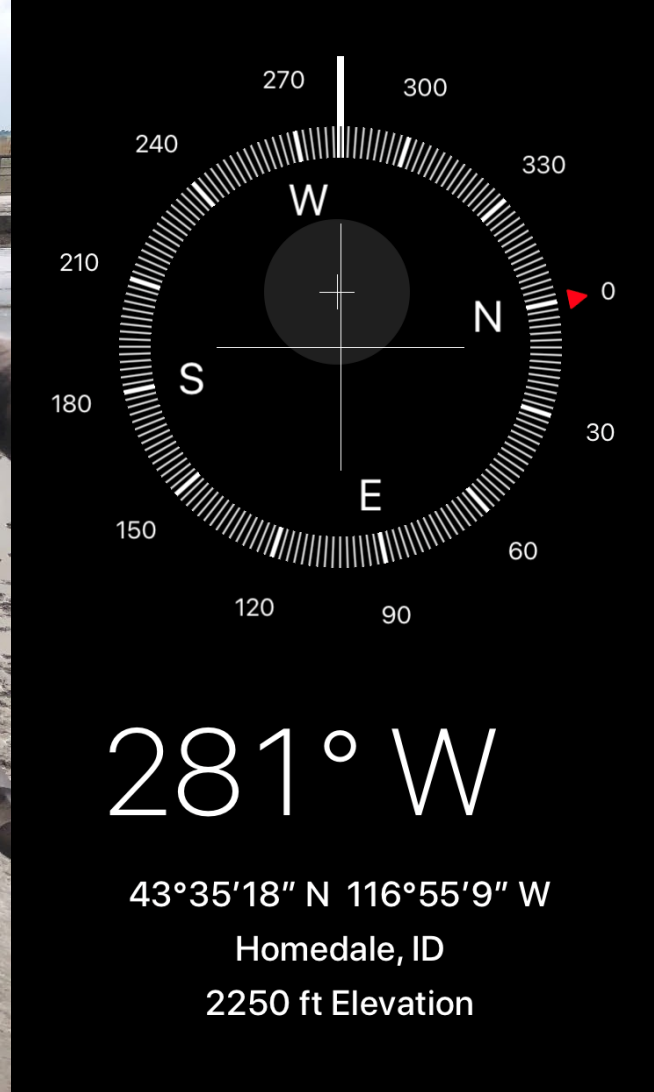
Photograph taken by Inspector Montague on May 21, 2019 facing 281 degrees West shows pooled liquids commingled with slurry from corrals approaching ditch that borders Owyhee Dairy on the North and Northwest side of facility.

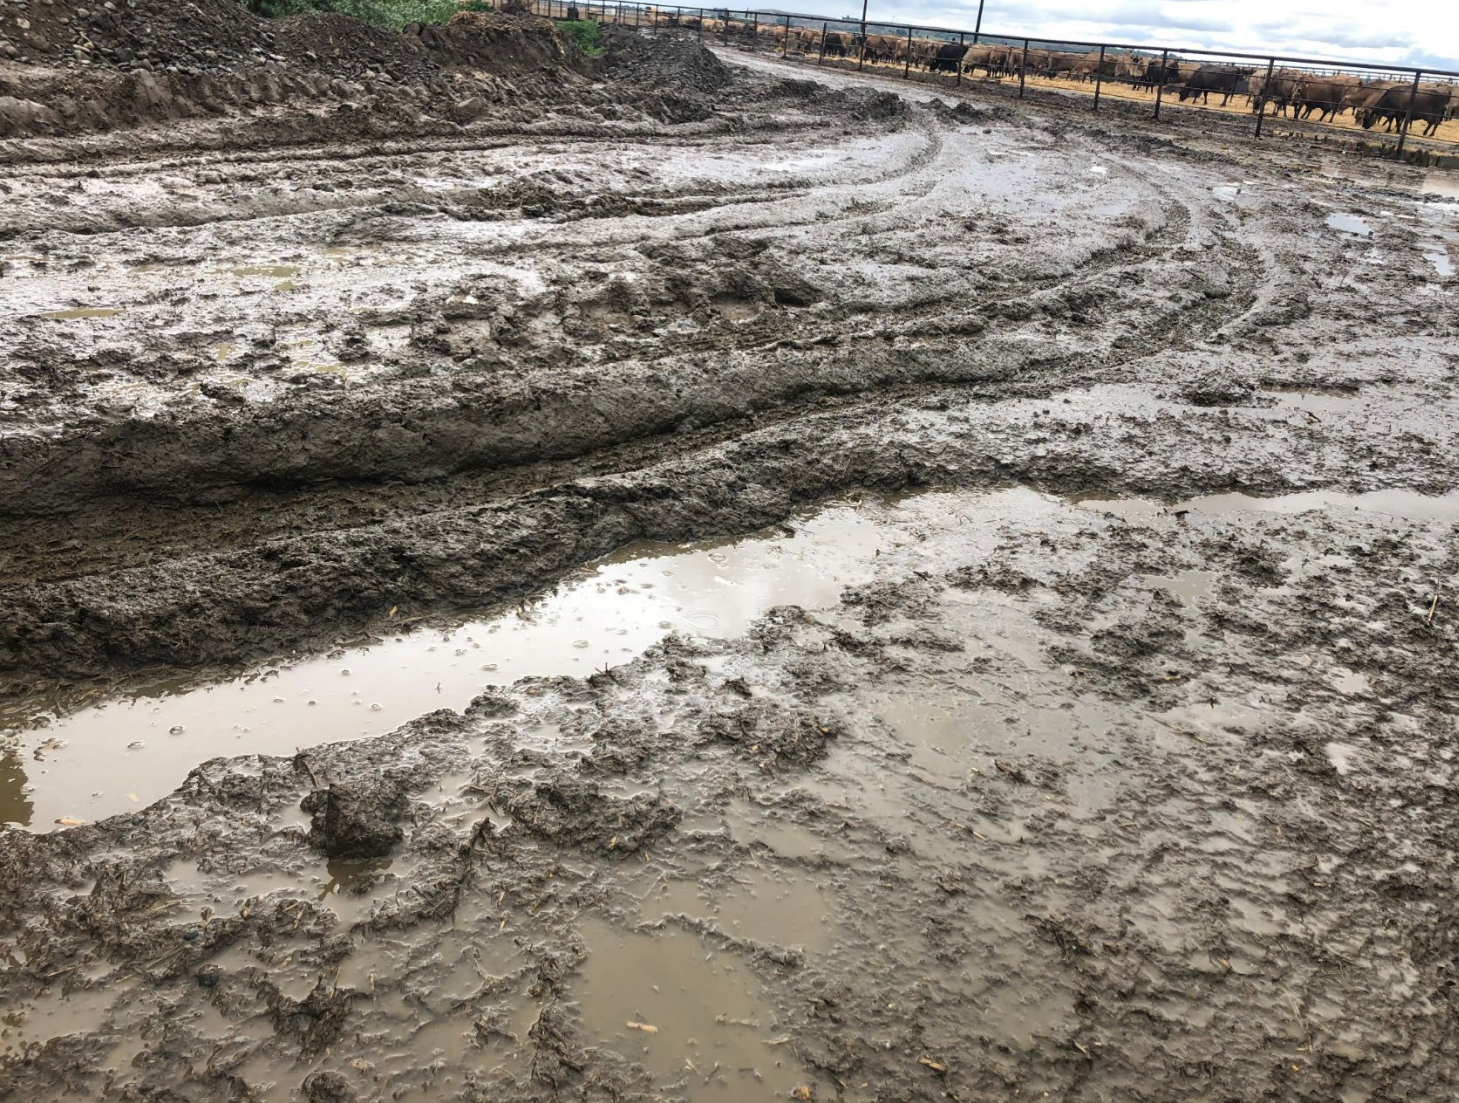
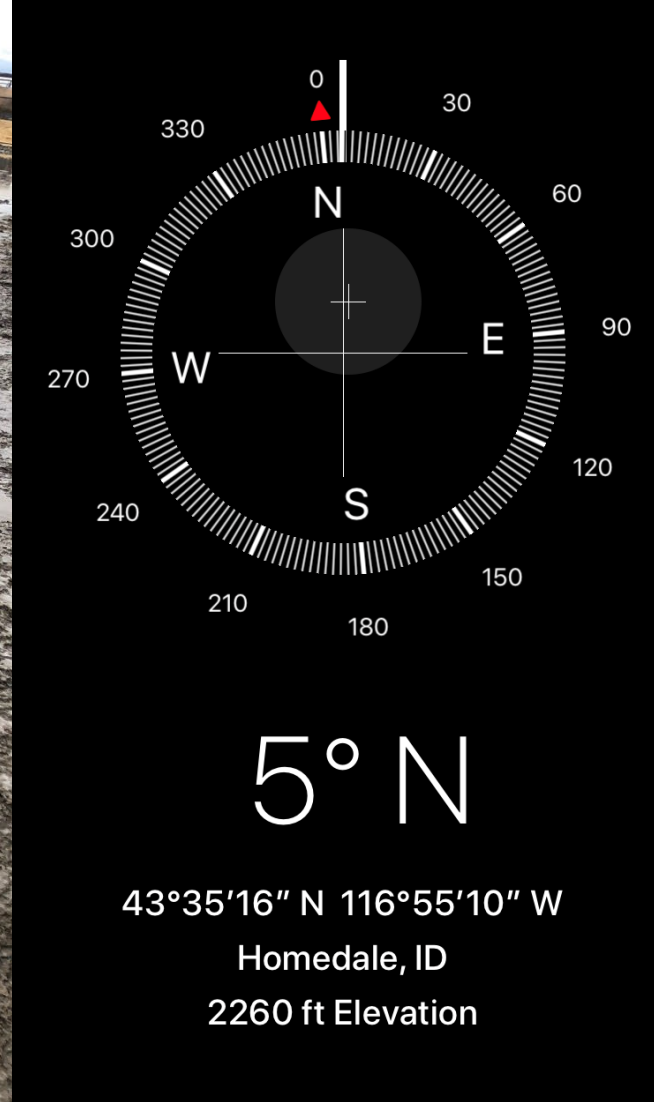
Photograph taken by Inspector Montague on May 21, 2019 facing 5 degrees North shows placement of uncontained solid slurry pile in the direction of the ditch bank that lies between the North corrals and the ditch that borders Owyhee Dairy on the North and Northwest side of facility. Slurry is shown coming out of corrals at the time of inspection.

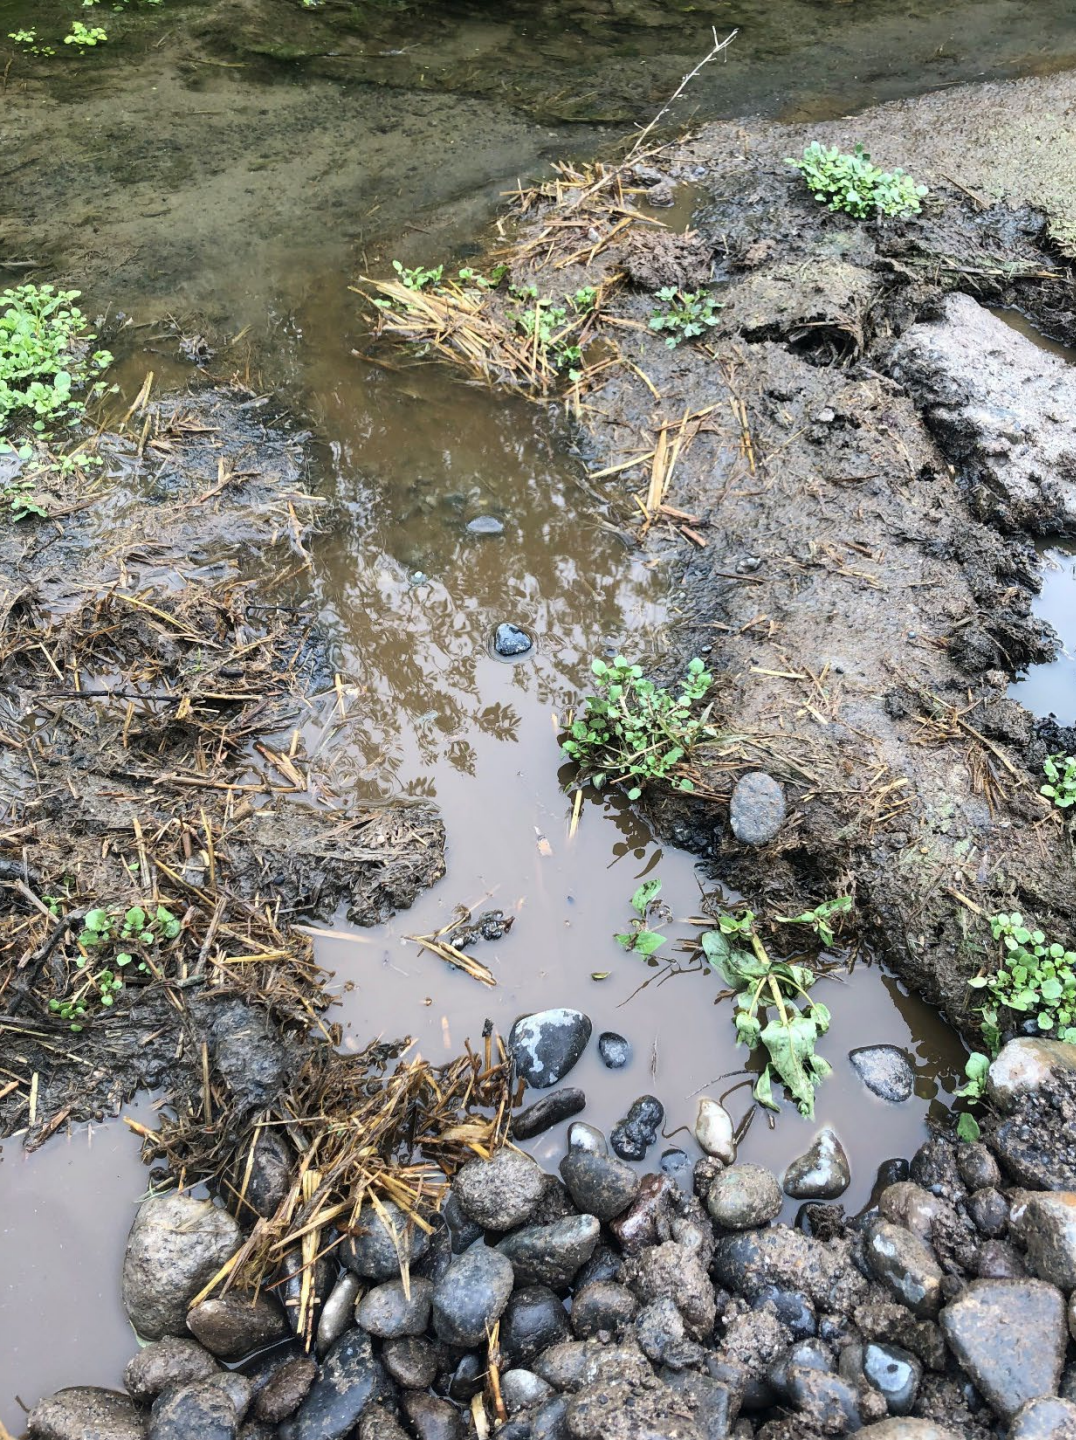
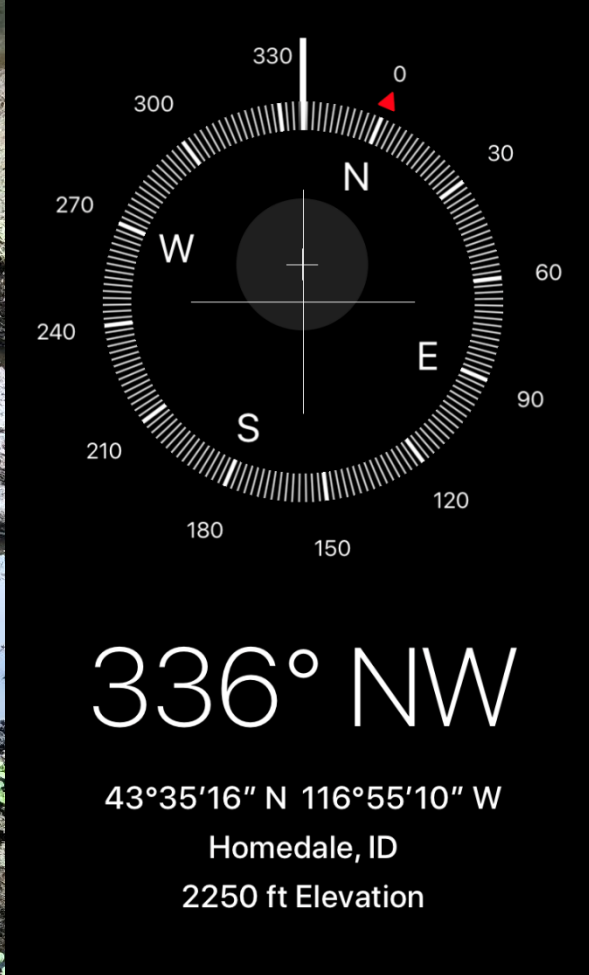
Photograph taken by Inspector Montague on May 21, 2019 facing 336 degrees Northwest shows evidence of past discharge directly North of pipe head coming out of bank that faces North corral area at Owyhee Dairy into Ditch that borders North and Northwest side of facility. Samples were collected at this time.

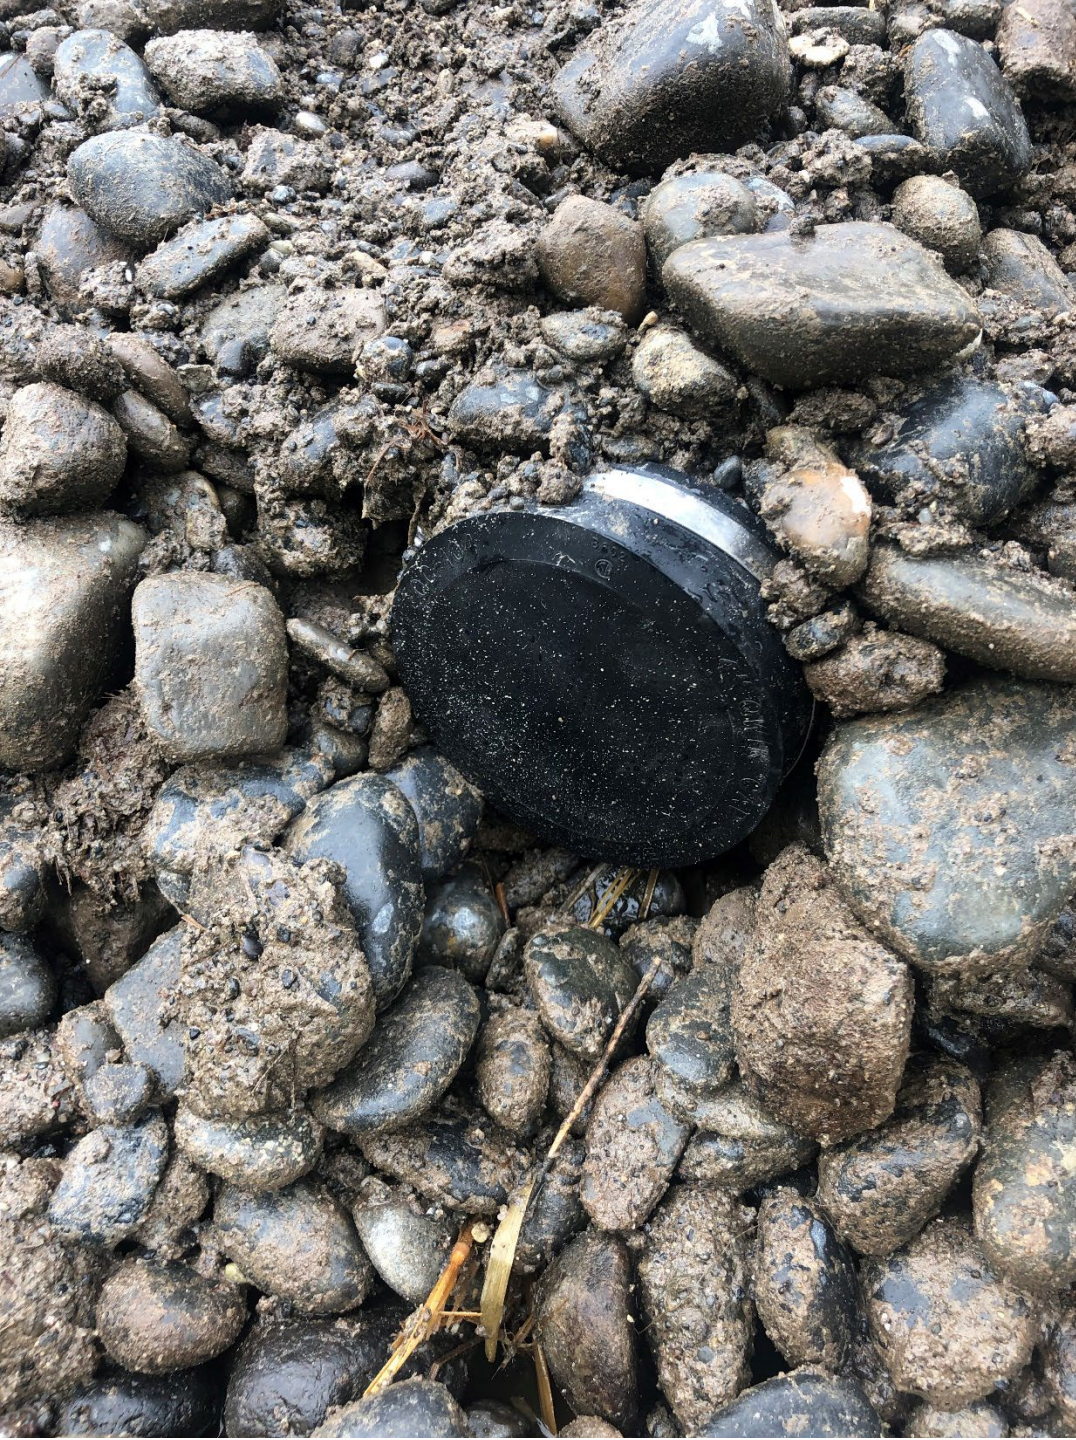
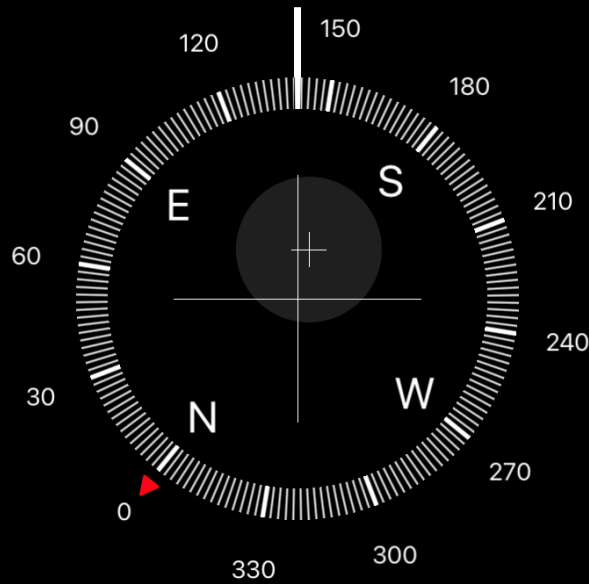
Photograph taken by Inspector Montague on May 21, 2019 facing 141 degrees Southeast shows capped pipe head coming out of bank that faces North corral area at Owyhee Dairy into Ditch that borders North and Northwest side of facility.

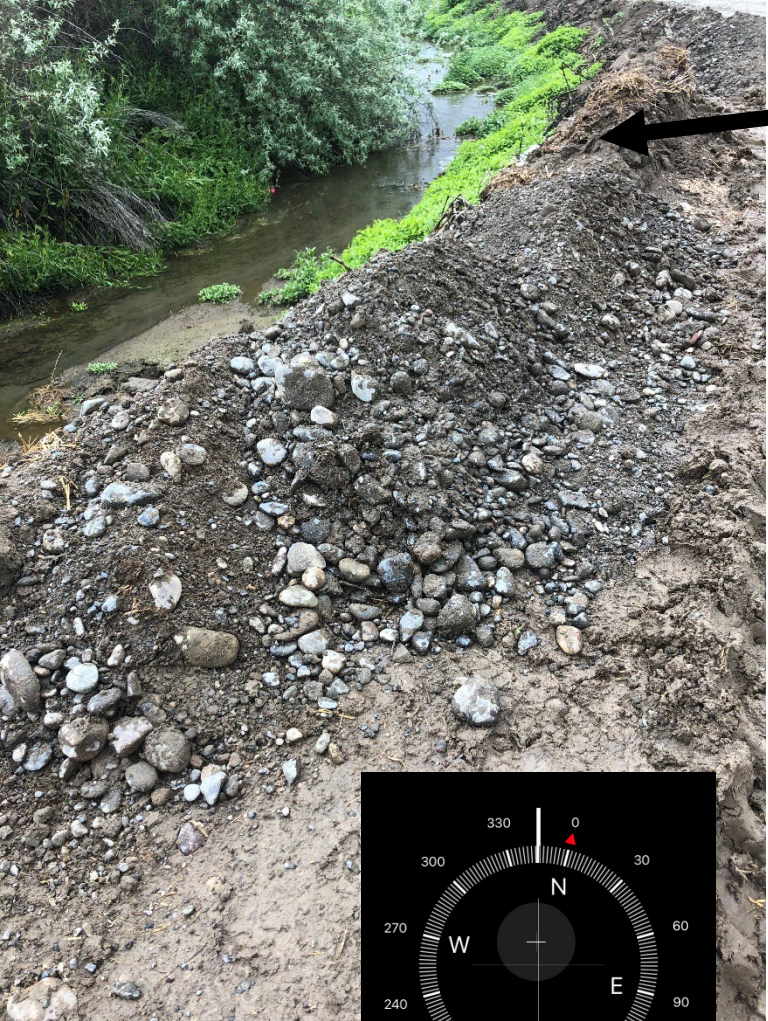
Photograph taken facing 345 degrees North by Inspector Montague shows placement of pipe head where she observed evidence of past discharge. Gravel and dirt was recently put in place along bank edge. Photograph taken May 21, 2019.

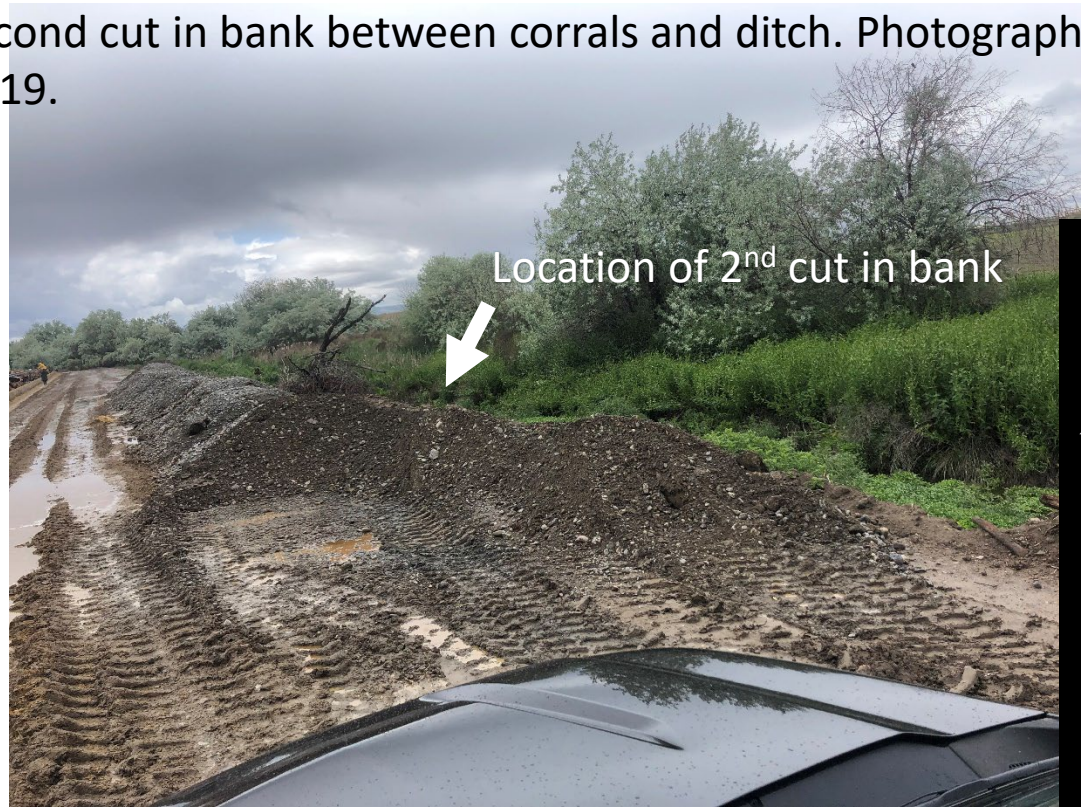
Location of 2<sup>nd</sup> cut in bank

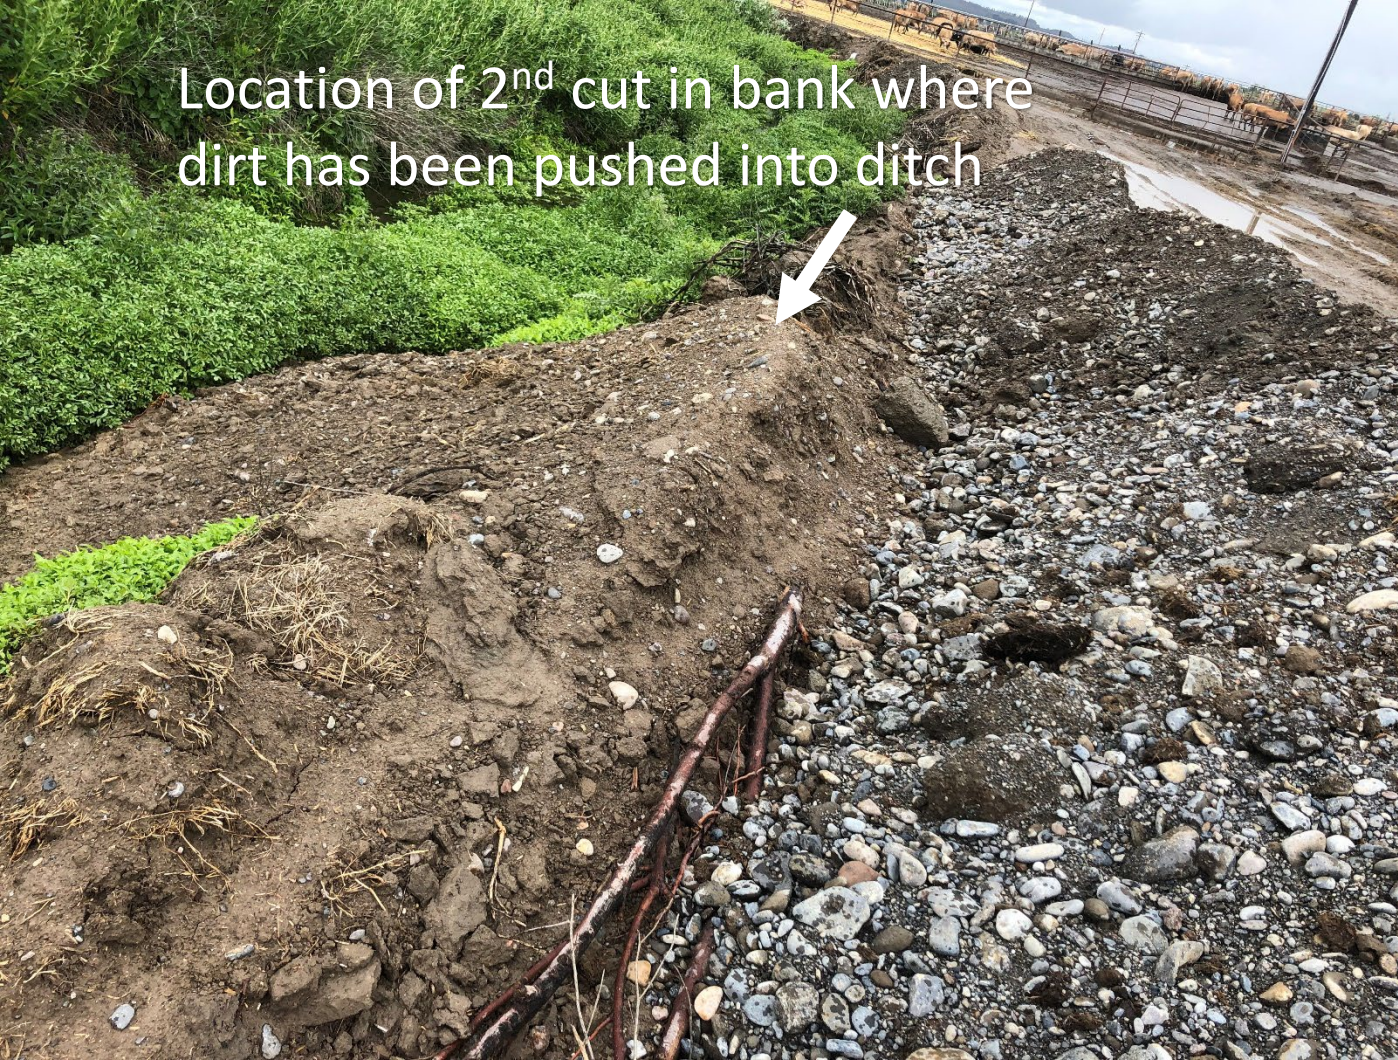
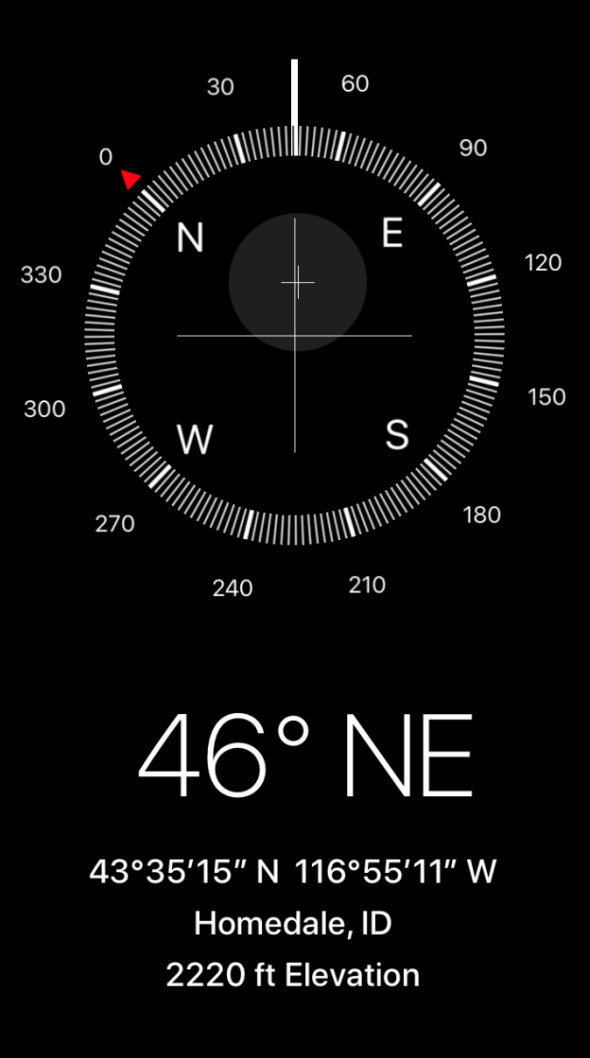
Photograph taken by Inspector Montague on May 21, 2019 facing 46 degrees Northeast shows approximate location of the second cut in the bank observed at the time of inspection along the bank that borders the North and Northwest side of Owyhee Dairy. Photograph shows dirt pushed into ditch and recently placed gravel and dirt along part of the ditch bank that borders the North and Northwest side of Owyhee Dairy.

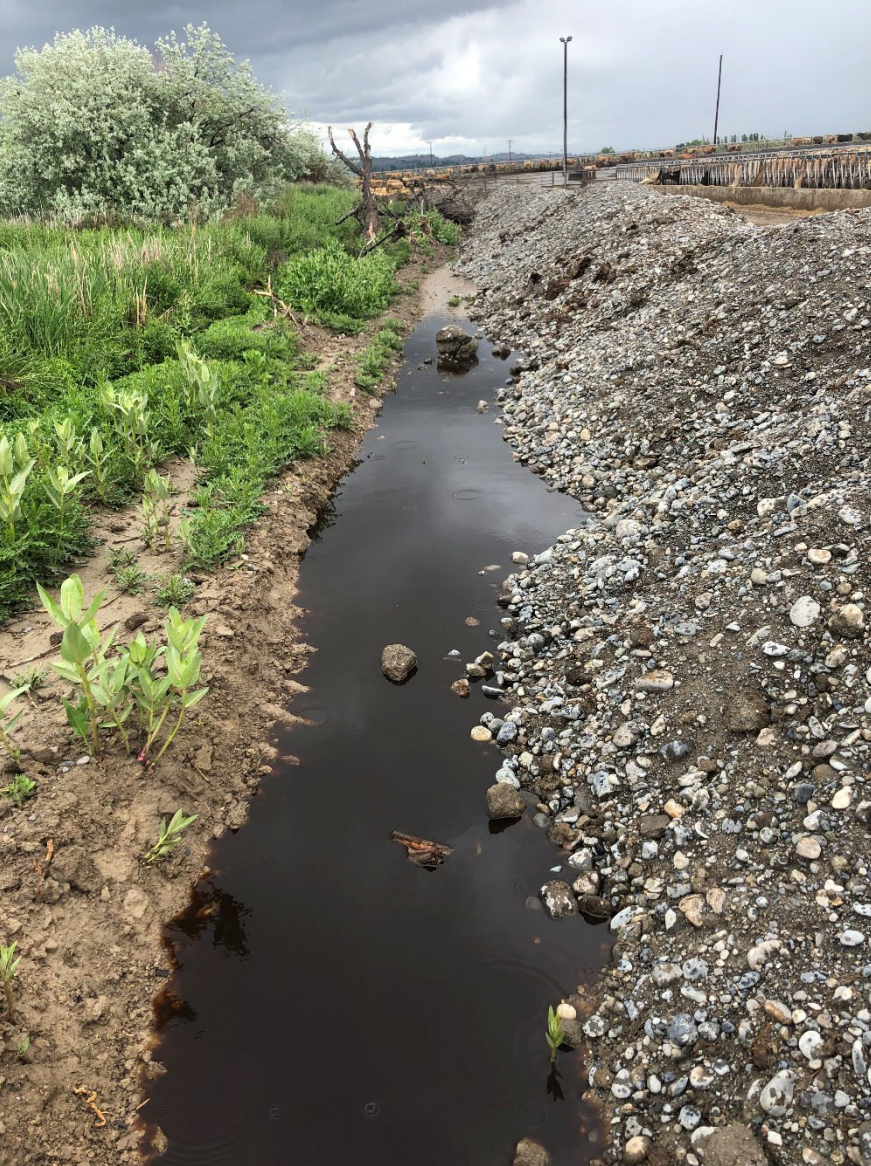
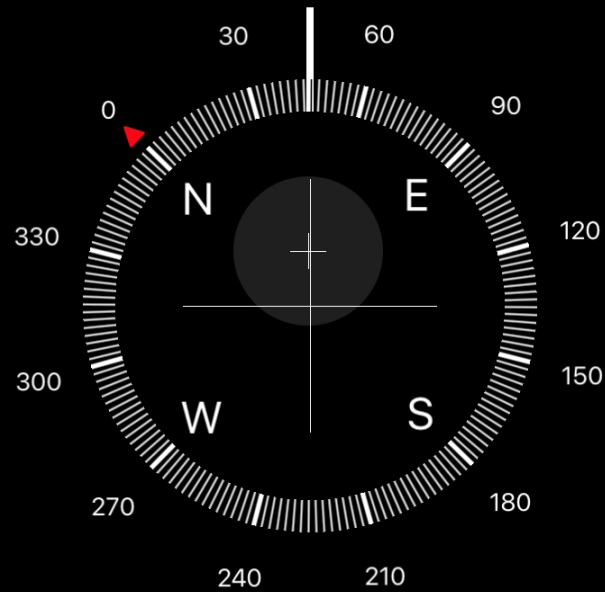
Photograph taken by Inspector Montague on May 21, 2019 facing 45 degrees Northeast shows placement of gravel and dirt over pooled effluent along the ditch bank that borders the North and Northwest side of Owyhee Dairy. Newly placed gravel and dirt line area in this location where 1 ½ - 2 foot berm was in place along ditch bank approximately one year ago.

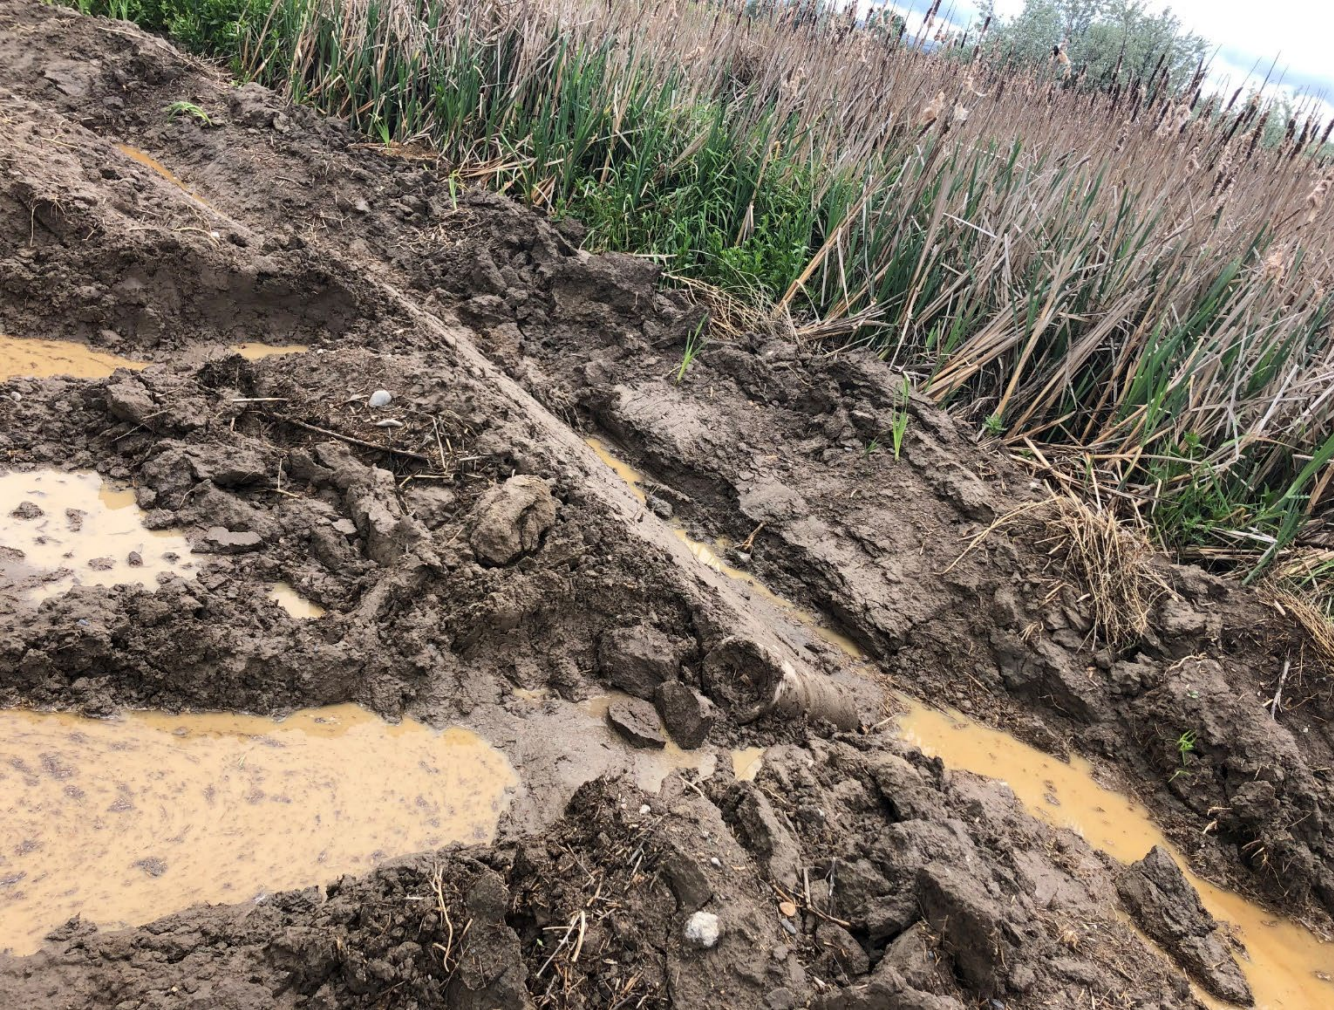
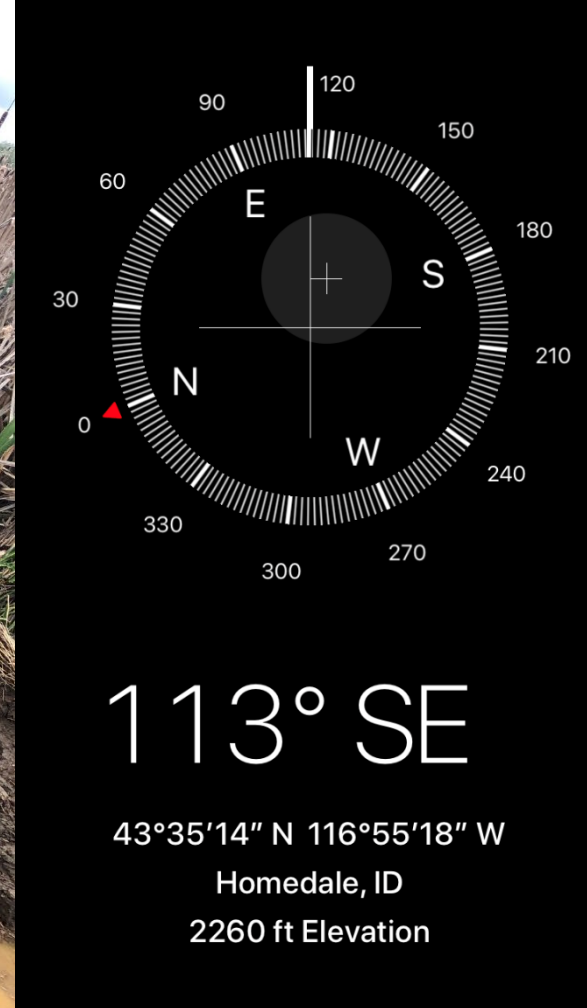
Photograph taken by Inspector Montague on May 21, 2019 facing 113 degrees southeast shows where field lateral that borders facility meets ditch along the north and northwest side of Owyhee Dairy. Bank has been compromised and runoff from corrals is able to commingle with ditch water.

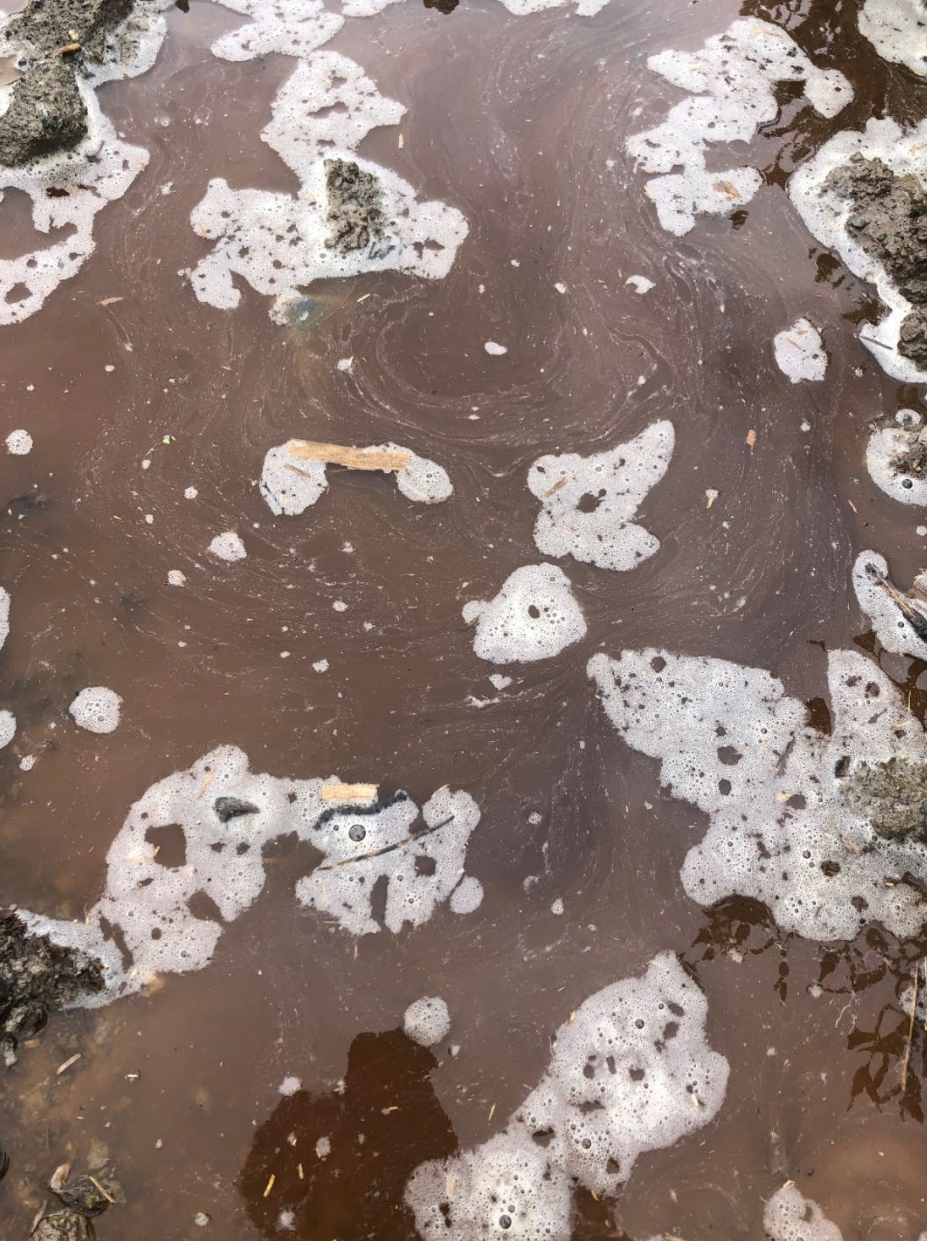
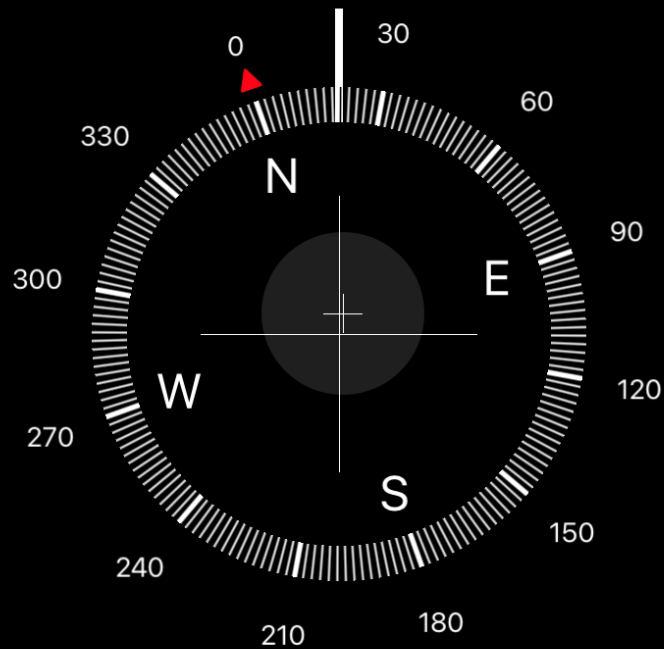
Photograph taken by Inspector Montague on May 21, 2019 facing 19 degrees north shows pooled stagnant effluent approximately two yards from the start of ditch that borders facility just north and northwest of the upper corrals and approximately four yards from where field lateral that borders facility ends.
